# UTILITY CUT RESTORATION

Miami, FL (1998) — EZ STREET Cold Asphalt Utility Repair

Technical Specs: 100 Ft. X 36 Ft.

Material: 70 tons of EZ STREET Cold Asphalt

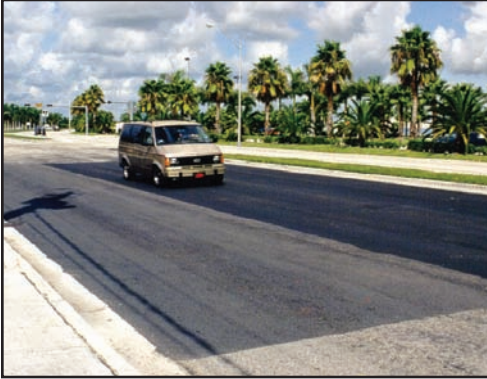
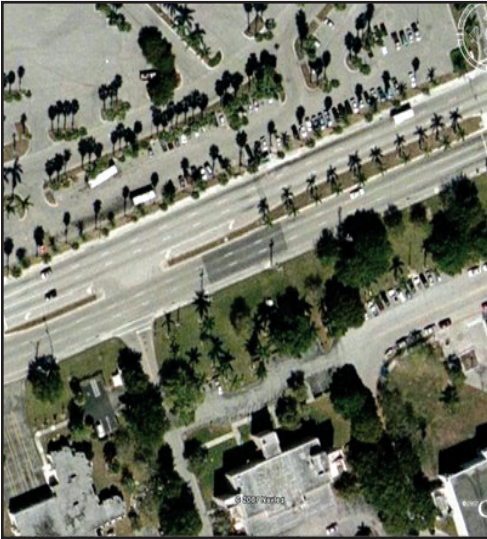
Utility cut restoration. Broken water main on SW 211th St., Miami, Florida USA. Failing conventional cold asphalt was excavated completely, sub-base recompact, EZ STREET was placed with a motor grader in two, 1½ – 2 inch lifts and then compacted with a steel wheel roller, patch was immediately reopened to traffic after installation.

Initial observations after installation of the EZ STREET Cold Asphalt showed no signs of: pushing, rutting, shoving, raveling or bleeding. Subsequent visits to the site have not revealed any degradation of the patch.
