CDOT Highway 36 Seam Repair

Colorado Asphalt Services, Inc.

Denver, CO (July 1, 2008) — EZ STREET® Cold Asphalt Seam Repair

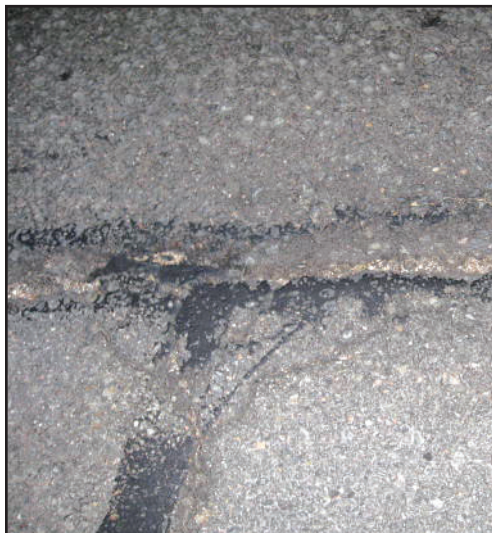
The seam ranged in size from ½ to 4 inches deep and up to 6 inches wide.

When rain, snow, and ice storms took their toll on Highway 36, dangerous sized seams (longitudinal cracking in the hot mix joints) began to form on the road surface. Ranging from ½ to 4 inches deep and some being up to 6 inches wide, the Colorado Department of Transportation deemed it necessary to repair a 2 mile stretch of the highway, beginning at mile marker 41 and moving west.

To prepare the seams for repair, the crew began by using an air compressor to clear debris from the surface cracks. Utilizing a lane closure, two crew members then shoveled EZSTREET bulk from the back hitch of a truck into the now cleared seams. A tandem truck followed behind them, wheel rolling the EZSTREET bulk into the seams. From then on, traffic additionally compacted the bulk. In all, the job used 3 tons of EZSTREET bulk.
